Industrial Production Co.

Infrared Thermography Inspection Report

**SAMPLE
REPORT**

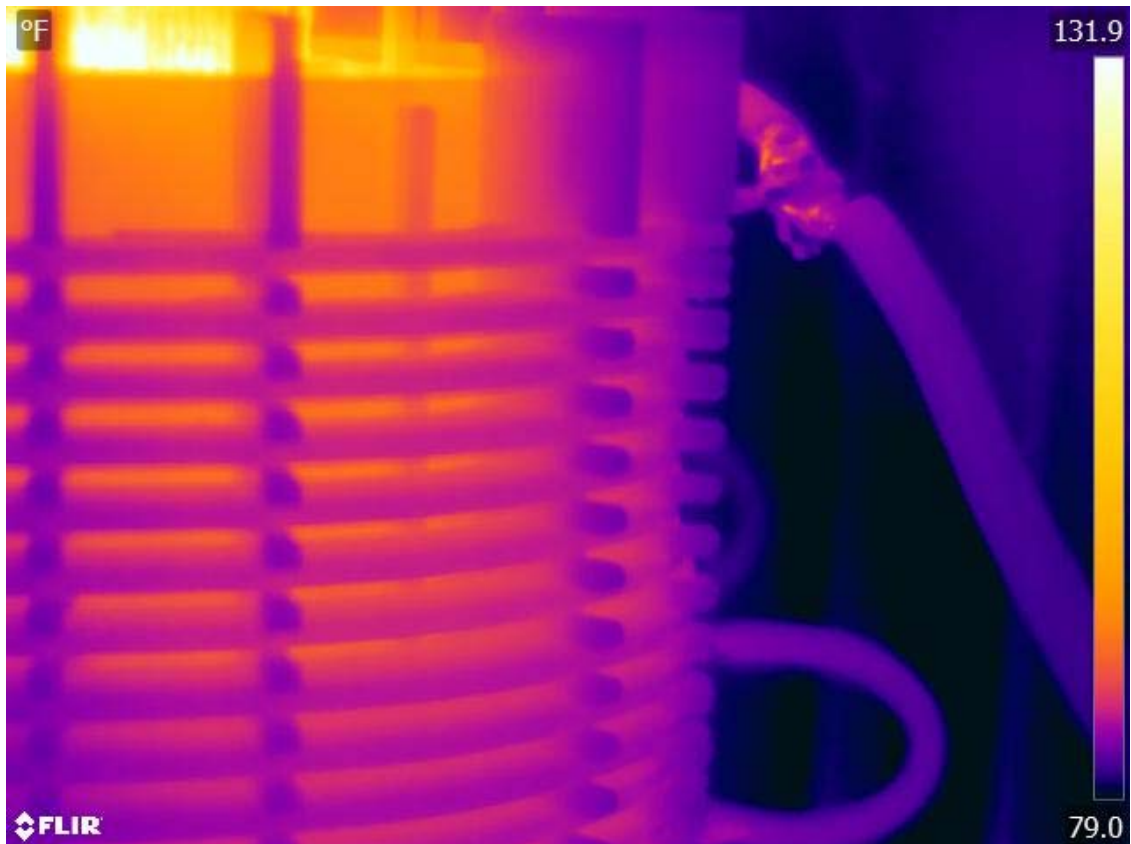
Normal Dry-Type Transformer Core
and Tap Connections Seen Through IR Window

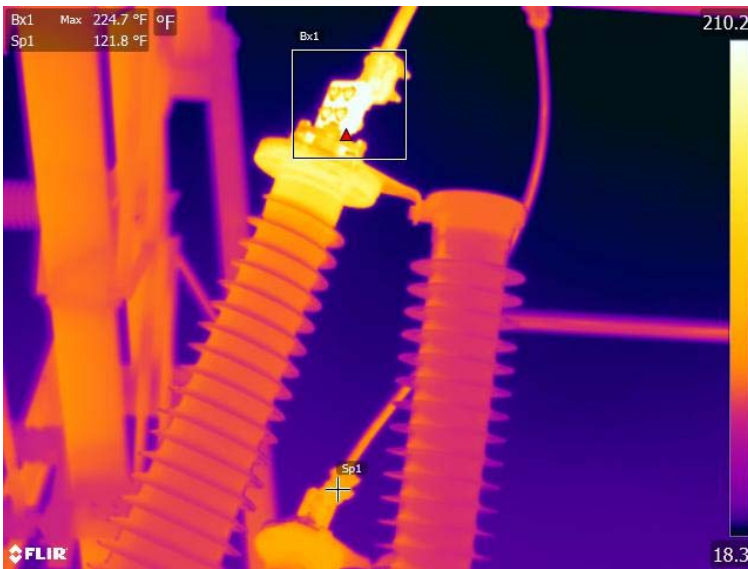
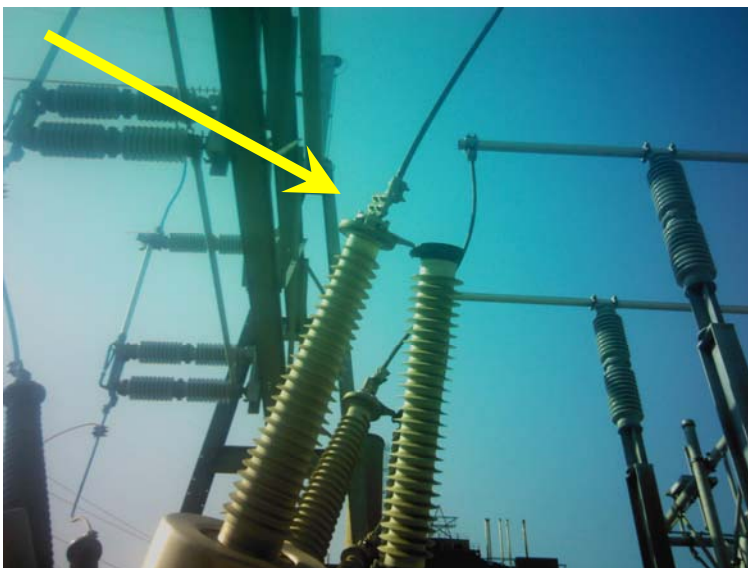
Equipment: Gas Circuit Breaker Line-Side north phase bushing connection

The connection on the north phase (right phase facing the breaker) line-side bushing is hot. The cable connection is ok. The heat is coming from where the terminal bolts to the bushing.

Severity: 3 high priority

<u>Temperatures:</u>	Ambient:	70 °F
	Hot Spot:	225 °F
	Reference:	122 °F
	Minimum Degree Rise:	103 °F

Disassemble the connection. Check the condition of the contacting surfaces and hardware. Clean or repair as necessary. Make sure the connection is clean and tight. See more pictures next page.

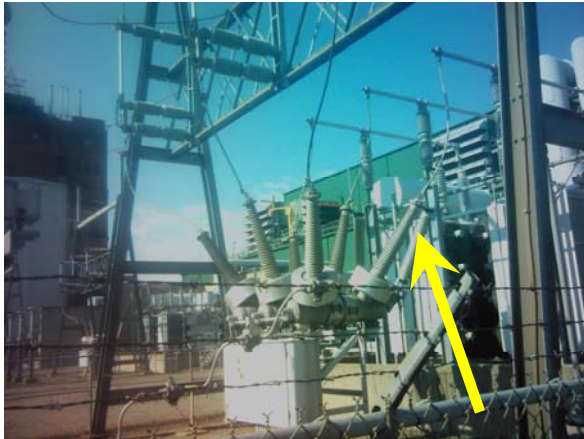
Gas Circuit Breaker Line-Side bushing connection on
the north phase

This is the same circuit breaker as shown on
Data Page 1

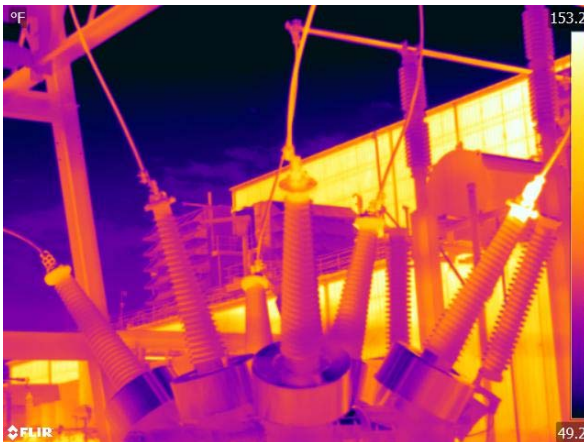
This is the same breaker as shown above and on
Data Page 1. The hot connection is shown with the
normal connections.

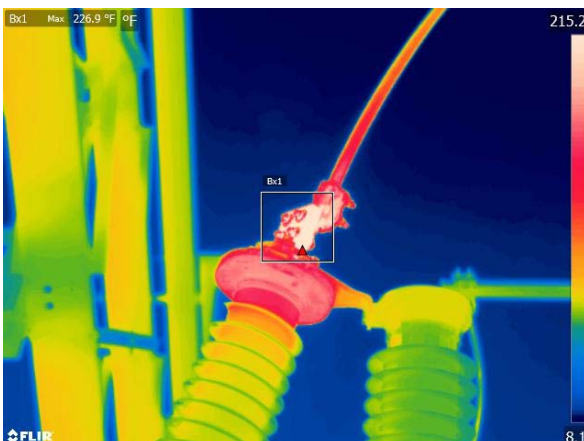
This is the same breaker as shown above and on
Data Page 1. The exact source of the heat can be
seen by using a different color pallet.

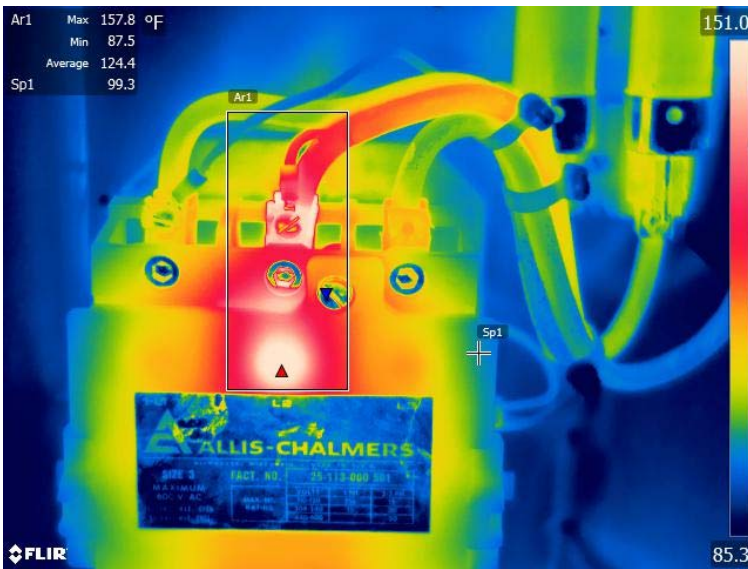
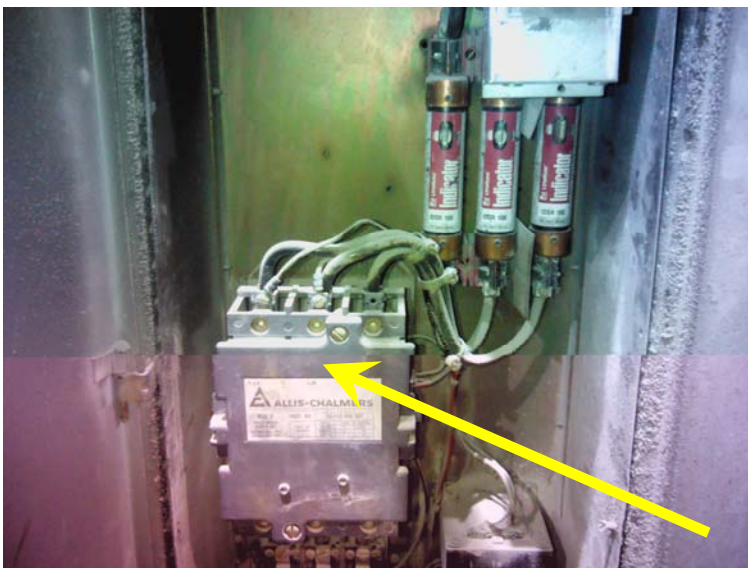
Equipment: Starter for the Baghouse Main Blower / internal hot connection (inside the starter)

The starter has a hot spot on the center phase coming from inside the starter. The highest temperature is not known because it's inside the case.

Severity: Unknown

<u>Temperatures:</u>	Ambient:	70 °F
	Hot Spot:	158 °F
	Reference:	124 °F
	Minimum Degree Rise:	>34 °F

Remove the starter cover and check the center phase near the top for a high resistance connection or bad contacts.

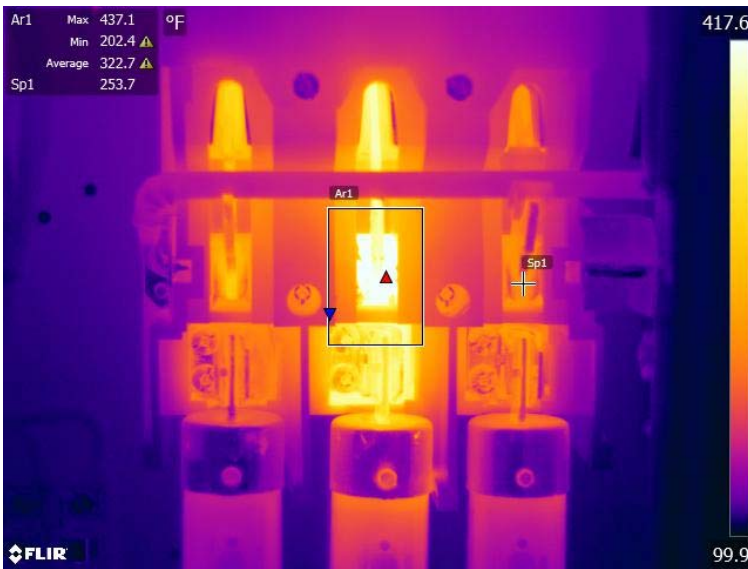
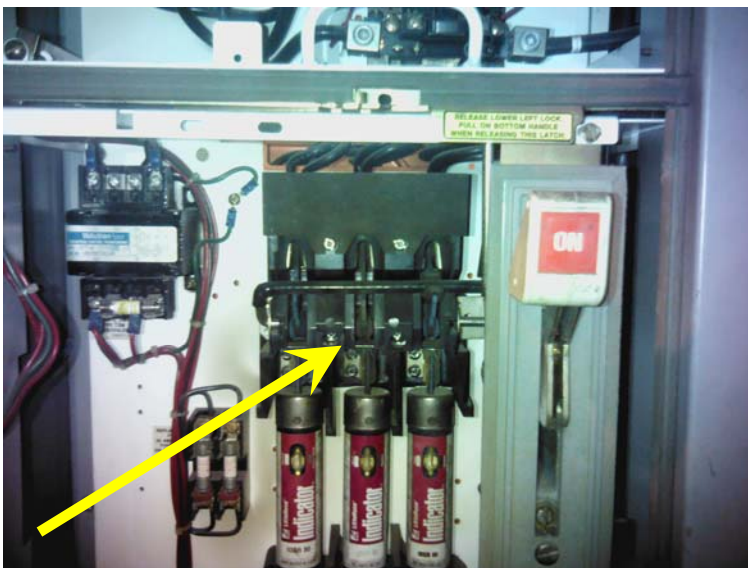
Equipment: MCC "A" / Ventilation Fan No. 3 motor control

The center phase hinge joint is very hot. The metal is discolored from the heat.

Severity: 3 high priority

<u>Temperatures:</u>	Ambient:	90 °F
	Hot Spot:	437 °F
	Reference:	253 °F
	Minimum Degree Rise:	184 °F

Exercise the switch. Clean and tighten the hinge contact area and the main contact area if possible.

It may require replacing the switch

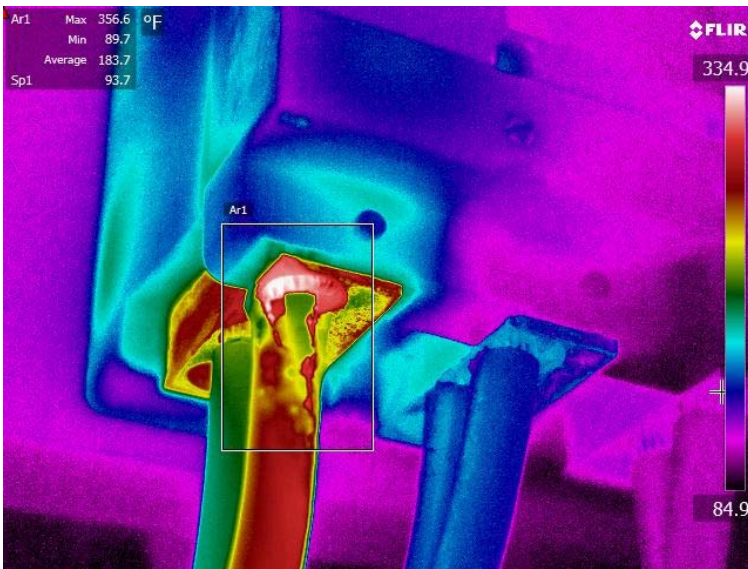
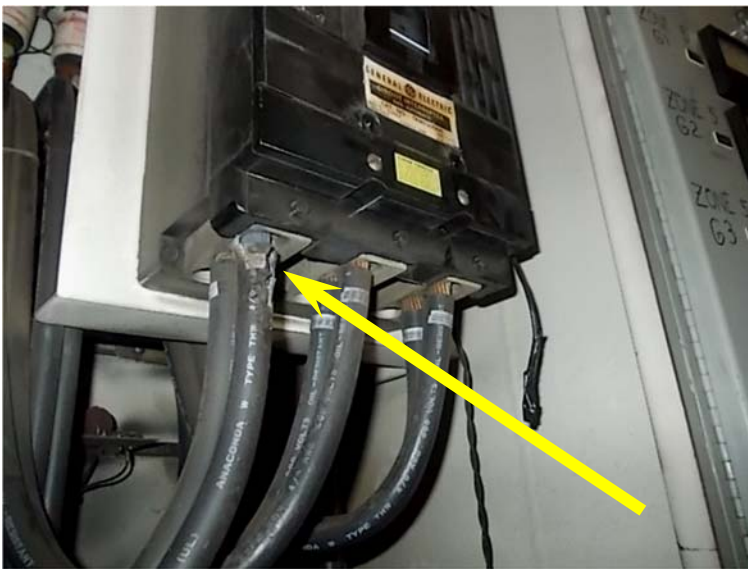
Equipment: MCC "H" – circuit breaker for Air Compressor No. 2

The bottom front cable on the left phase of the main circuit breaker is very hot.

The insulation is burnt and crispy.

Severity: 3 high priority

<u>Temperatures:</u>	Ambient:	55 °F
	Hot Spot:	357 °F
	Reference:	94 °F
	Minimum Degree Rise:	263 °F

Disconnect the cable and inspect the cable and breaker. Cut off the heat-damaged end of the cable and make a new connection.

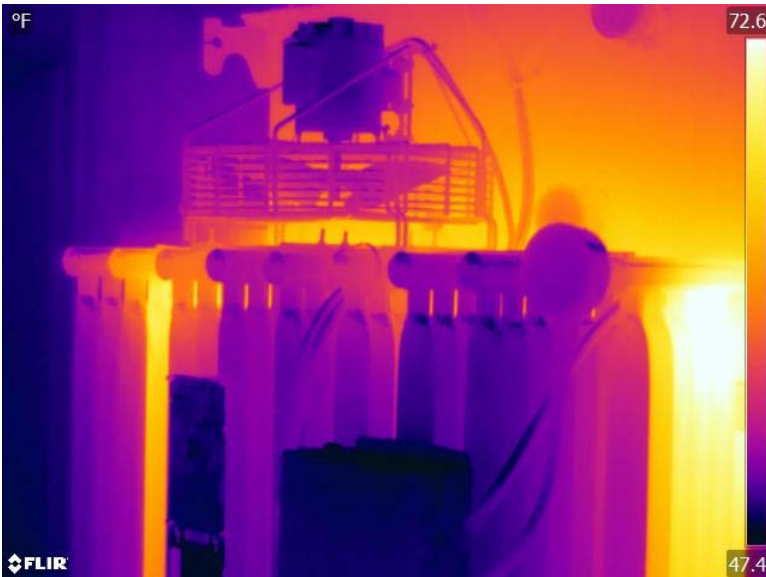
East Transformer

Low oil level – oil not making it into most of the radiator tubes.

Dark radiator tubes are cold therefore no oil and no cooling.

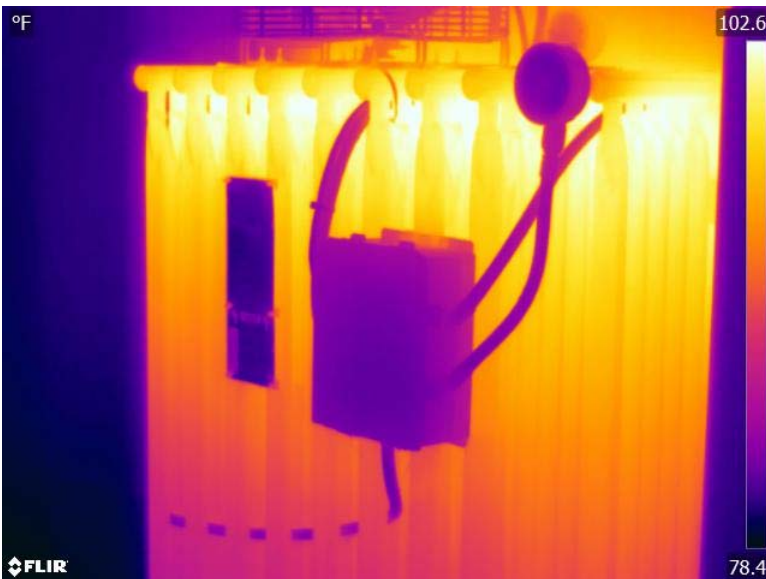
Same transformer after adding oil to the correct level.

All radiator tubes are warm, have oil moving through them, transformer is being cooled normally.

No further action is necessary.

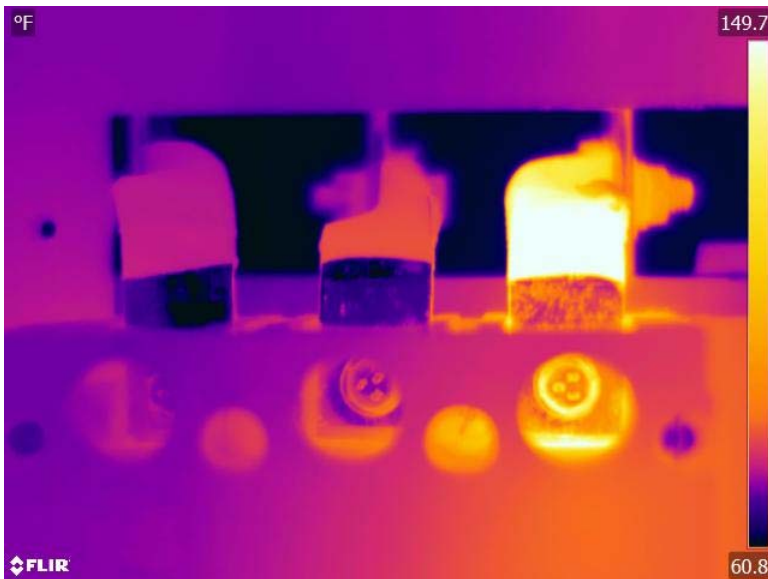
MCC "D"

Hot connection on circuit breaker for Auxiliary Coolant Pump as found at the time of the previous inspection.

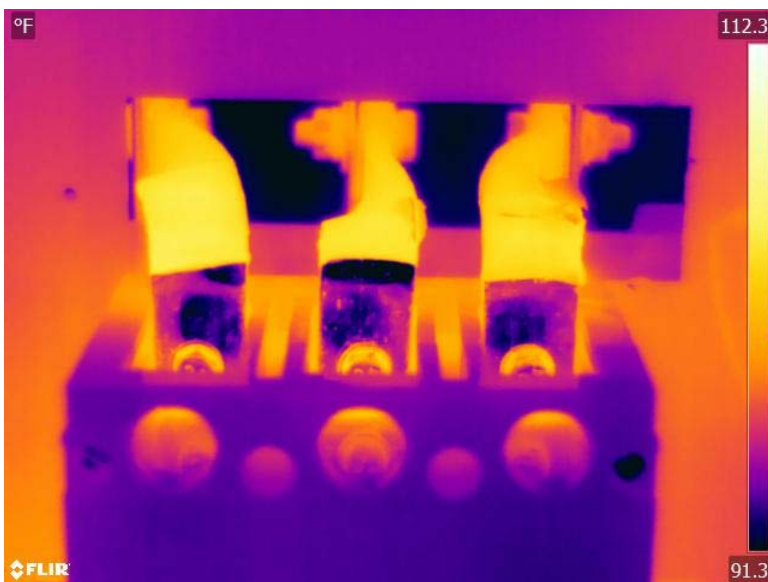
Same circuit breaker as above with normal condition after servicing the connection.
